**Test Report N° 2814127-2**

**TEST OF GLASSWOOL DUCT ACCORDING TO EN 13403**  
**EROSION – AIRTIGHTNESS – RESISTANCE TO PRESSURE**

EQUIPMENT ID: KNAUF INSULATION CLIMACOUSTIC 25 R 0,75

REFERENCE DOCUMENT(S): EN 13403

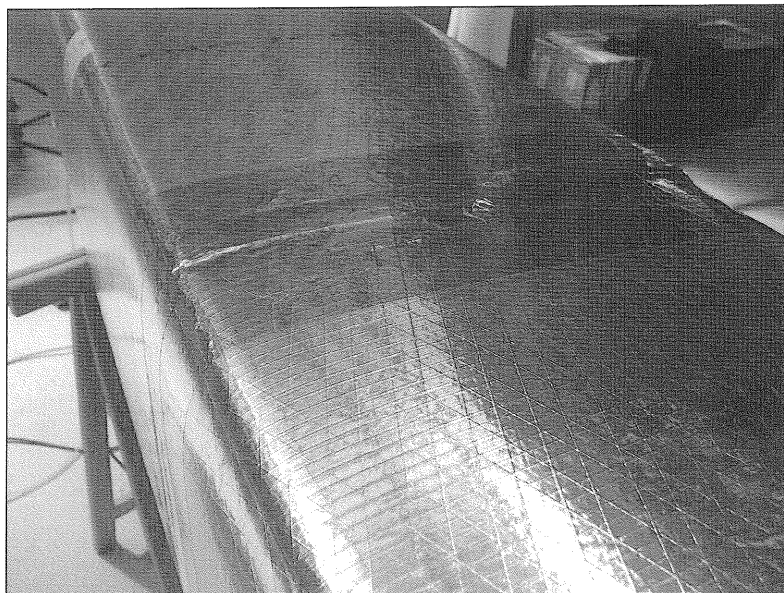
**Figure 7 : Views of the sample after the pressure test**

As it can be seen on Figure 7, the joining material remained intact. There is no evidence of other damage, which would cause the sample to become unusable.

<b>RESISTANCE AGAINST PRESSURE TEST</b>	
Pressure = 2000 Pa	
KNAUF INSULATION CLIMACOUSTIC 25 R 0,75	
The joining material remained intact. There is no evidence of other damage, which would cause the sample to become unusable.

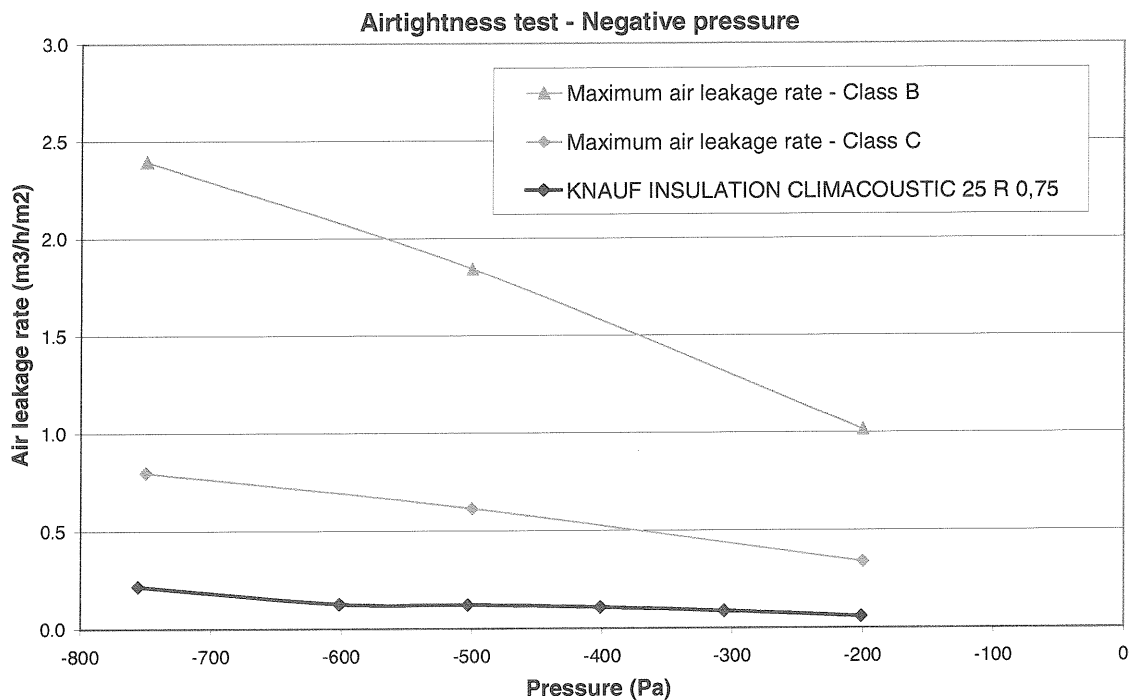
**Figure 9 : Leakage flow rate according to the negative pressure**

Pressure Pa	Airflow rate m3/h	Airflow rate at 20°C and 101325 Pa		Leakage rate	
		m3/h	l/s	m3/h/m2	l/s/m2
-201	0.6	0.6	0.2	0.06	0.02
-306	0.9	0.9	0.2	0.09	0.02
-401	1.1	1.0	0.3	0.11	0.03
-503	1.2	1.2	0.3	0.12	0.03
-601	1.3	1.2	0.3	0.13	0.03
-756	2.2	2.1	0.6	0.22	0.06

<b>AIRTIGHTNESS TEST</b>		
	Pressure	KNAUF INSULATION CLIMACOUSTIC 25 R 0,75
Airtightness class	-756 Pa	C
Airtightness class	1005 Pa	C

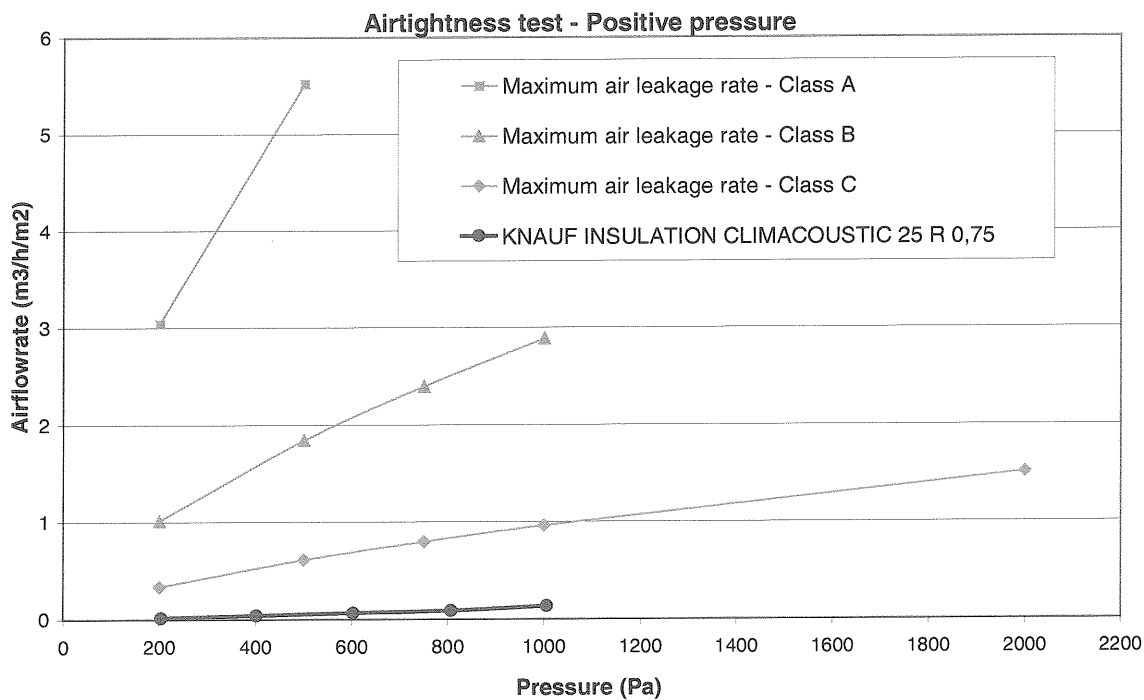
**Figure 10 : Leakage flow rate according to the positive pressure**

Pressure Pa	Airflow rate m3/h	Airflow rate at 20°C and 101325 Pa		Leakage rate	
		m3/h	l/s	m3/h/m2	l/s/m2
203	0.2	0.2	0.0	0.02	0.00
401	0.4	0.4	0.1	0.04	0.01
602	0.7	0.7	0.2	0.07	0.02
806	0.9	0.9	0.2	0.09	0.02
1005	1.4	1.3	0.4	0.13	0.04
